Manhole Inspection Summary

Manhole # S29Q__019MH

Insp Date: **11/26/08 7:41 AM**

Location Address: **1267 W Ostend St**

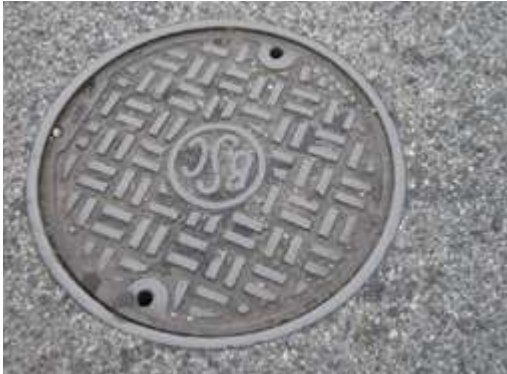
cover pic

Condition: **Sound**

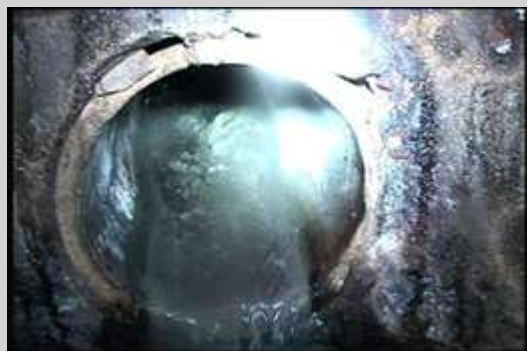
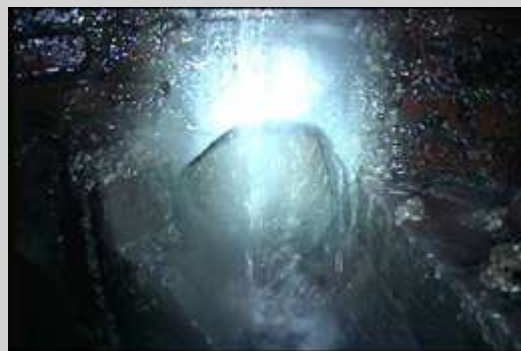
7 O'Clock Inflow

8 in. Circular Gravity Sewer

Pipe In @ 7 O'Clock

Drop In @ 7 O'Clock

Pipe Height: **8.4** (in.) Rod and Bar (Angled)

Pipe Material: **Clay** ☐ Pipe Lined
